OFFICE PARK - ANAHEIM, CA

PROJECT DESCRIPTION

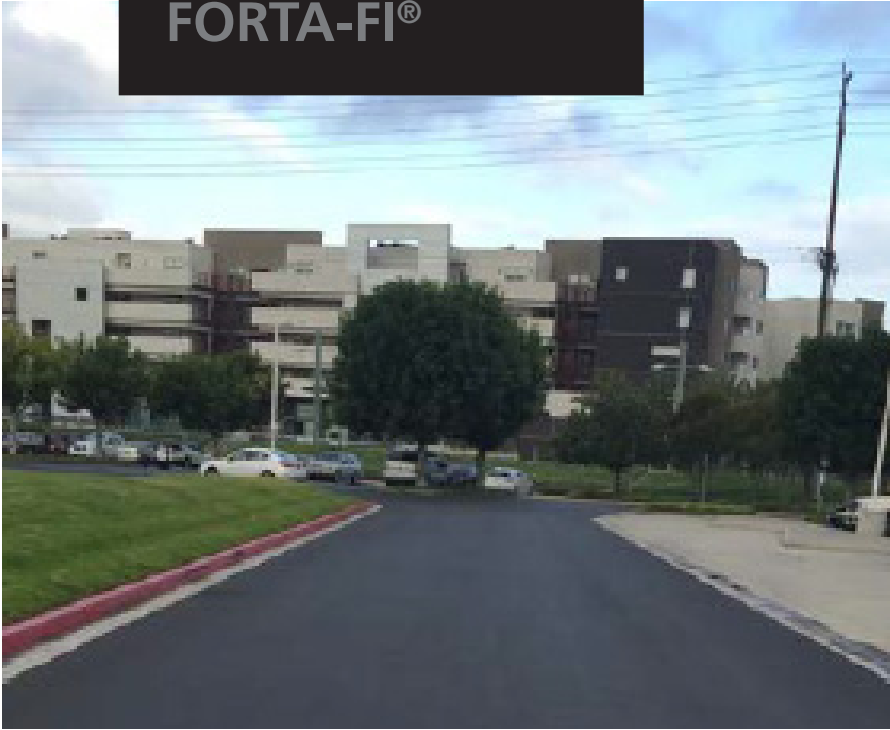
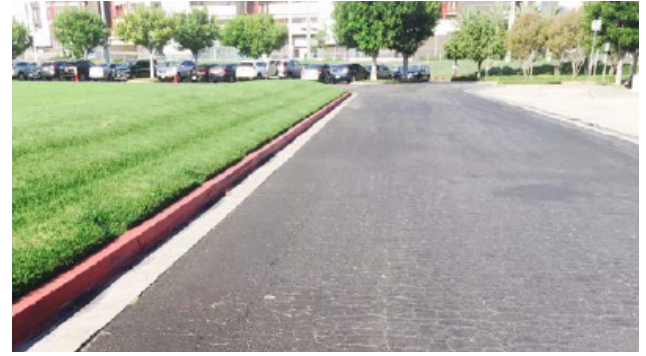
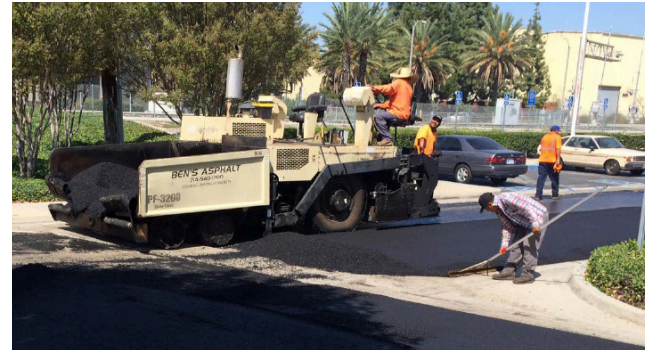
A 1.5" FORTA-FI[®] reinforced overlay was used to rehabilitate the badly deteriorated parking lots and drive aisles around this commercial office development. Existing pavement distresses included severe alligator cracking and some areas where rutting was prevalent.

Nine months after construction, the FORTAfi[®] overlay is holding up well and **shows no signs of cracking**. The pavement was edge-milled to 4' prior to placing the overlay.
