BOEING ROADS & PARKING LOT - MESA, AZ

PROJECT DESCRIPTION

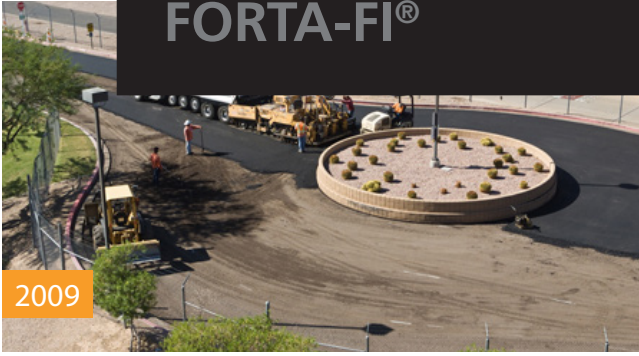
Date: October 2009

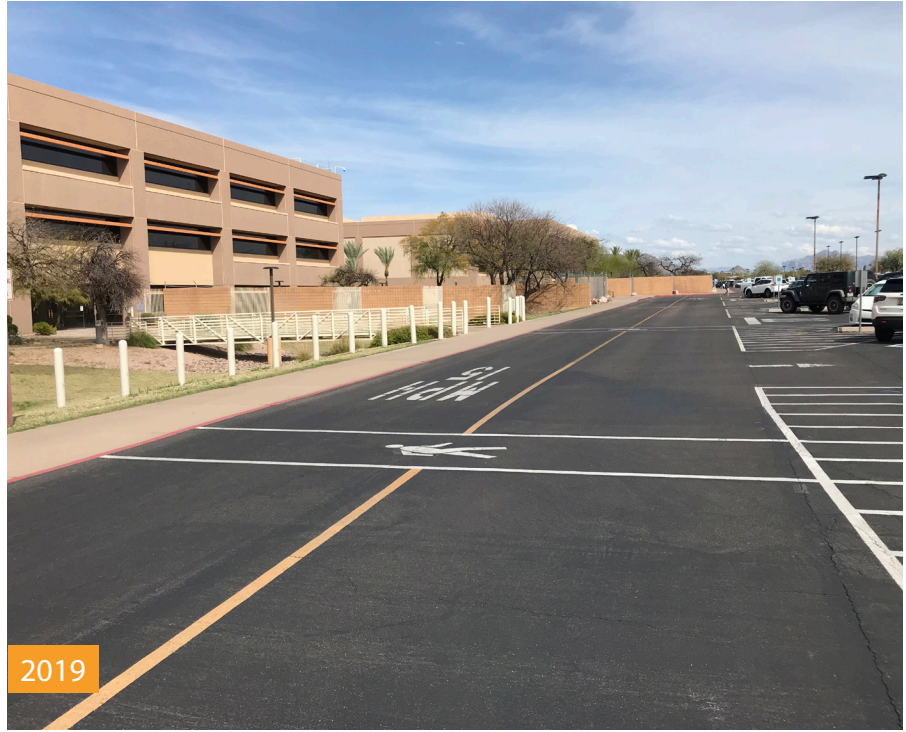
2019

After 10 years, the Boeing parking lot in Mesa, AZ is exceeding expectations. Only 3 or 4 hairline cracks can be seen along the entire length. Some pavement preservation maintenance has taken place but compared to the parts without fiber, there is a noticeable difference. This is unheard of in Arizona where pavement takes a beating from temperature swings and usually shows thermal and block cracking after 10 years.
